AIRCRAFT ACCIDENT REPORT

UNCONTROLLED DESCENT AND COLLISION WITH TERRAIN
USAIR FLIGHT 427
BOEING 737-300, N513AU
NEAR ALIQUIPPA, PENNSYLVANIA
SEPTEMBER 8, 1994

**NTSB/AAR-99/01
PB99-910401
Notation 6472A
Adopted March 24, 1999**

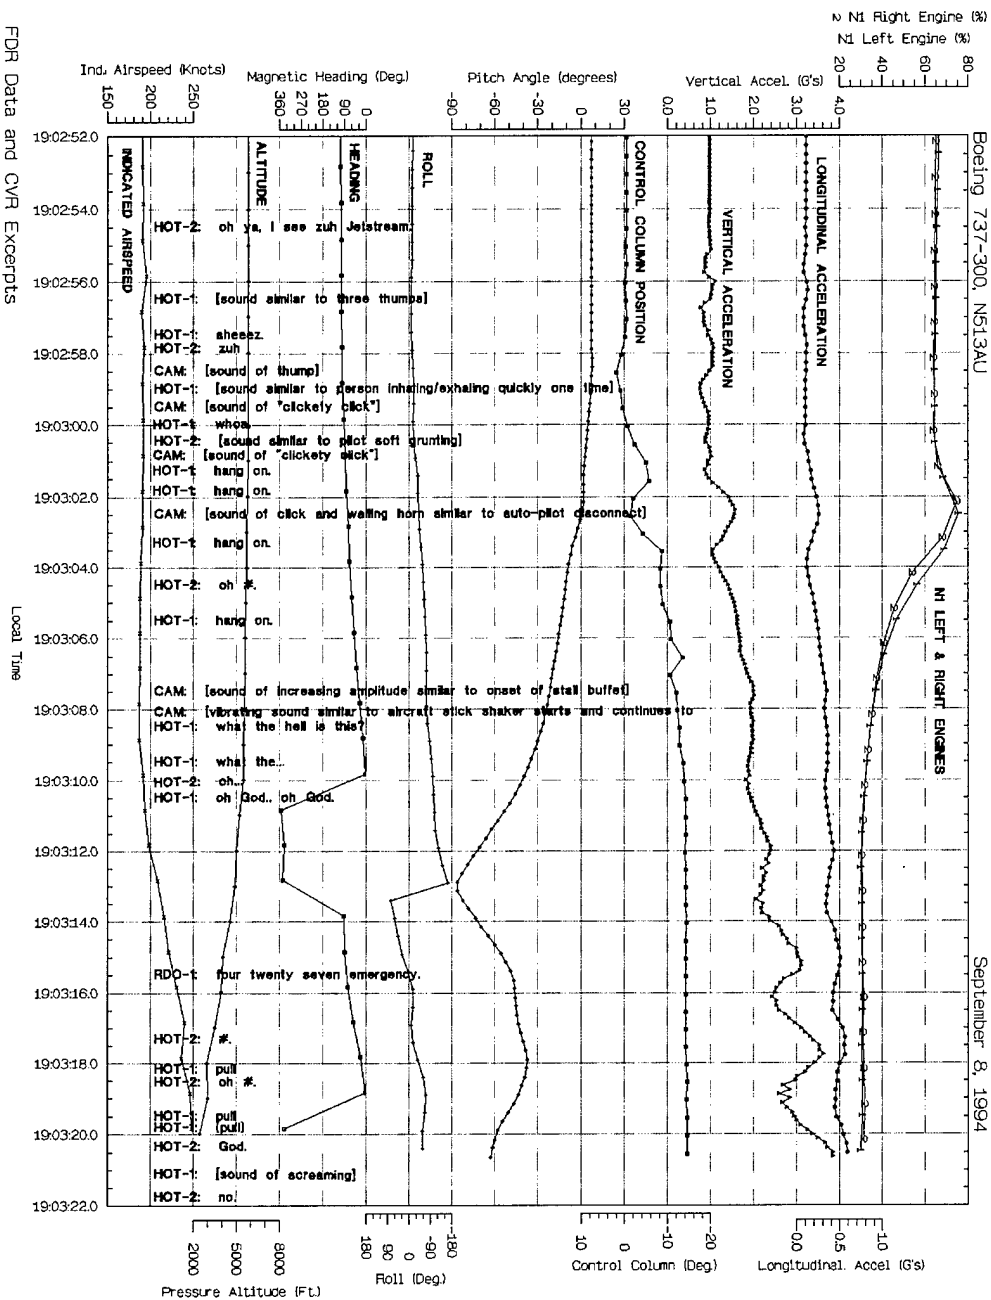
Figure 1. FDR data during the final 30 seconds of USAir flight 427.

FDR information revealed that, just before 1903:03, the airplane's left bank angle had increased to about 43°, the airplane had begun to descend from its assigned altitude of 6,000 feet msl, the control column had started to move aft, and the airspeed started to decrease below 190 knots. Less than 1 second later, the CVR recorded the sound of the autopilot disconnect horn. During the next 5 seconds, the FDR recorded increasing left roll, aft control column, decreasing altitude, and a decreasing airspeed to about 186 knots.

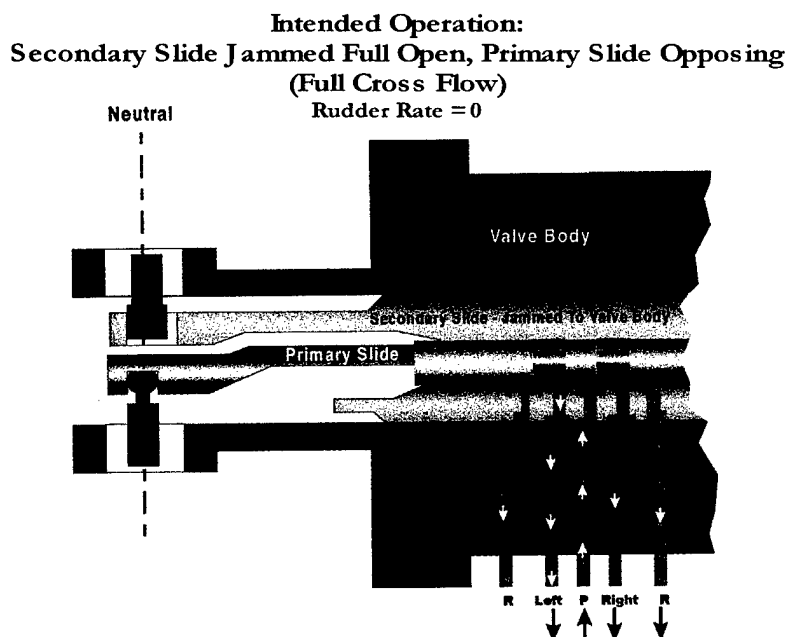
Figure 16. PCU servo valve intended operation with the secondary slide jammed to the servo valve housing and primary slide opposing.

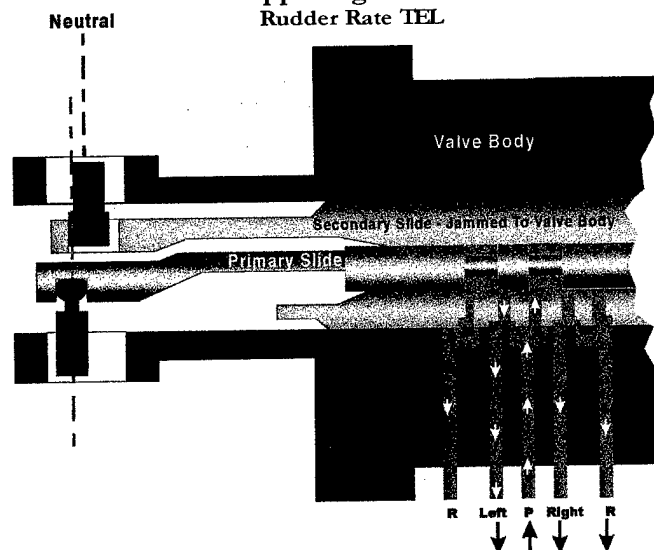
**Newly Discovered Failure Effect:
Secondary Slide Jammed Full Open, Primary Slide Over-Stroke
In Opposing Direction
Rudder Rate TEL**

Figure 17. PCU servo valve with the secondary slide jammed to the servo valve housing and the primary slide in the overtravel condition.

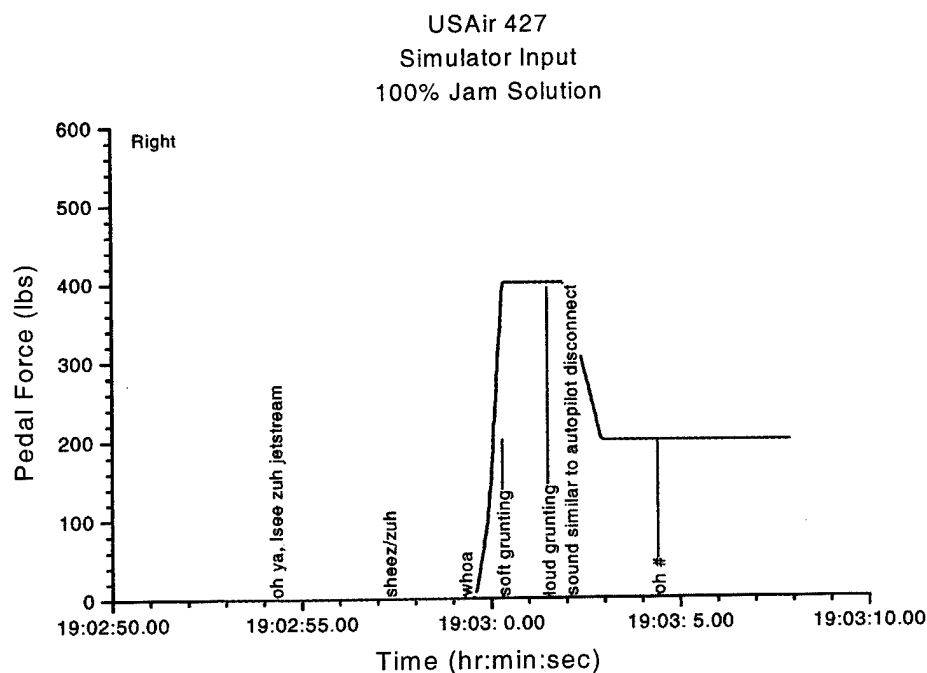
Figure 18a. Pilot rudder pedal force for USAir flight 427.

¹⁷⁶ The Safety Board's best-match simulation used 400 pounds of rudder pedal force reducing to 200 pounds, based on ergonomic and other research data (see section 1.18.8). However, the Safety Board was also able to match the USAir flight 427 FDR data using only the minimum pedal force necessary to sustain full rudder authority (about 70 pounds).

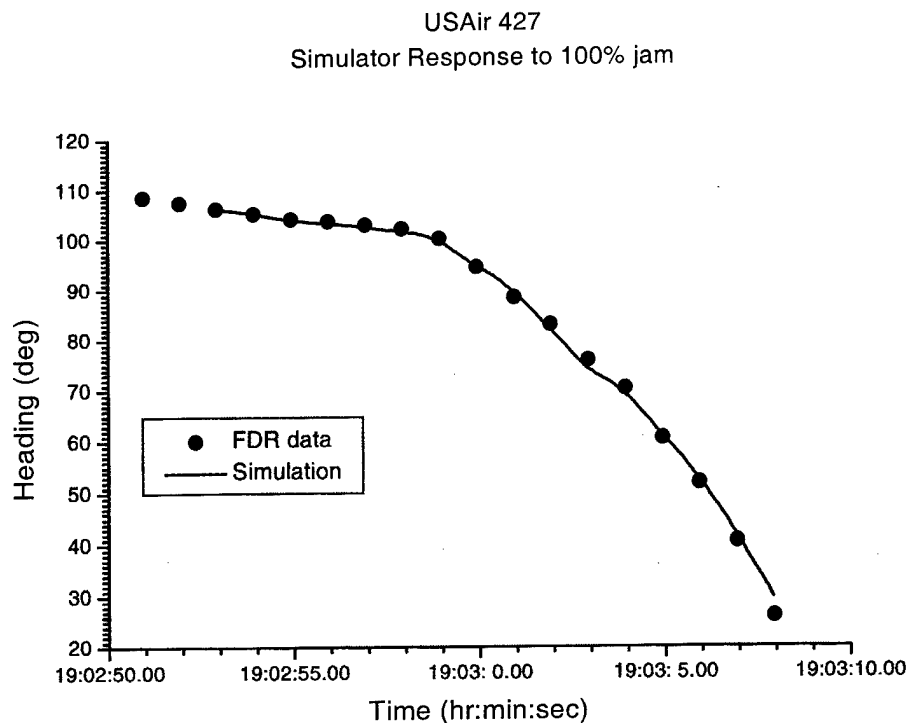
The heading data that resulted from the simulation with the secondary slide jammed to the servo valve housing at the 100-percent position matched the FDR heading data better than simulations with the secondary slide jammed at the other three positions. Control surface position data are presented for the 100-percent jam. The pilot rudder pedal force time history is shown in figure 18a.¹⁷⁶ The rudder surface and control wheel positions are shown in figures 18b and 18c, and the resultant heading, bank angle, pitch angle, and vertical acceleration data, compared with the FDR data, are shown in figures 18d through 18g, respectively.

Figure 18d. Heading data for USAir flight 427.
